Volunteer Fire Chief Killed when Buried by Brick Parapet Wall Collapse – Texas

Fatality Assessment and Control Evaluation Investigation Report # F2008-21

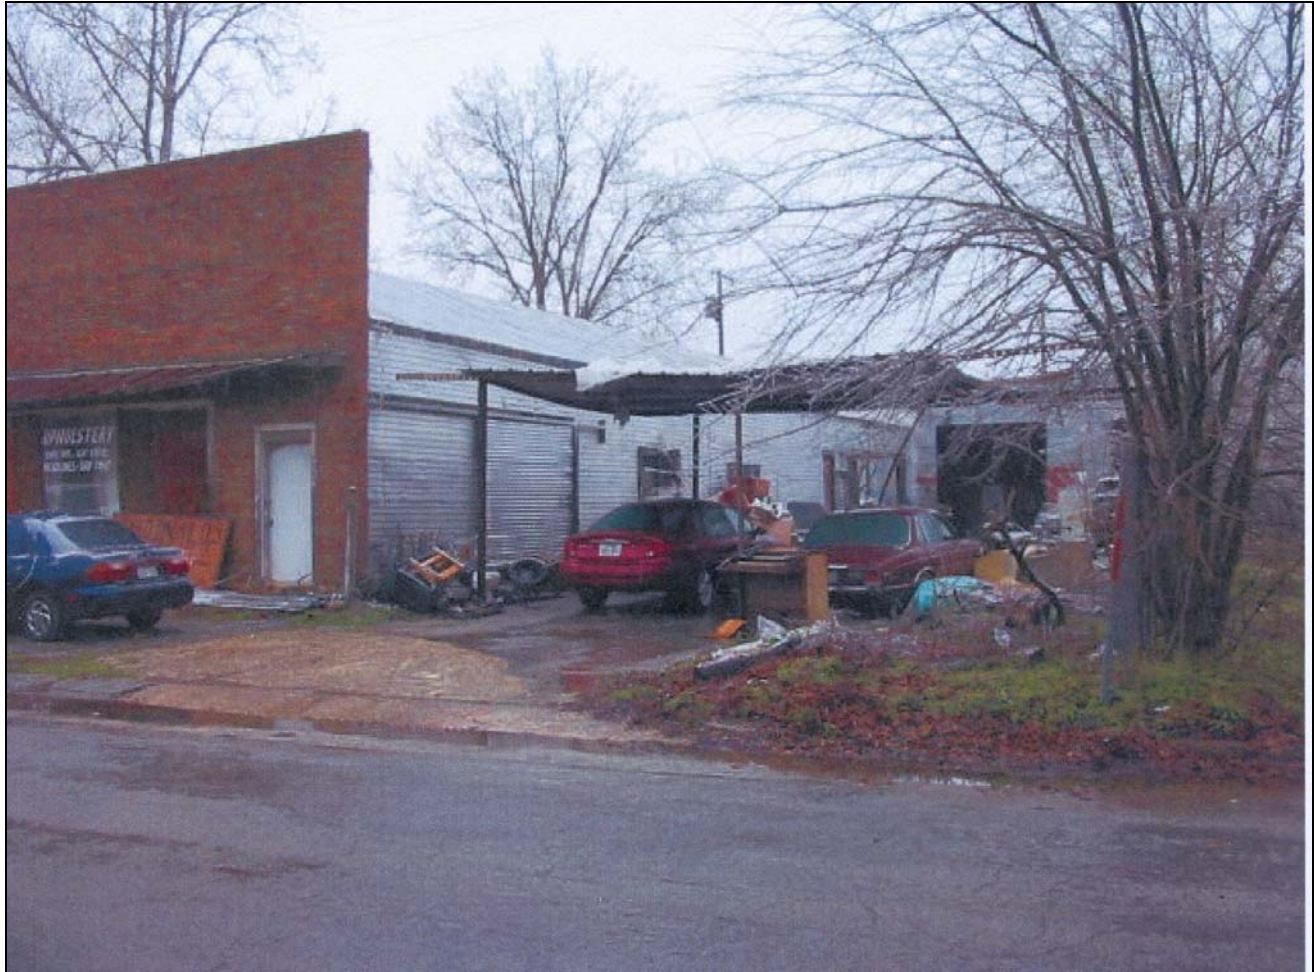
Photo 1. Photo taken from street in front of structure some time before the fire. Note the height of the brick parapet wall in relation to the roof peak. Also note the rain awning connected to the parapet wall.
(Photo courtesy of the fire department.)

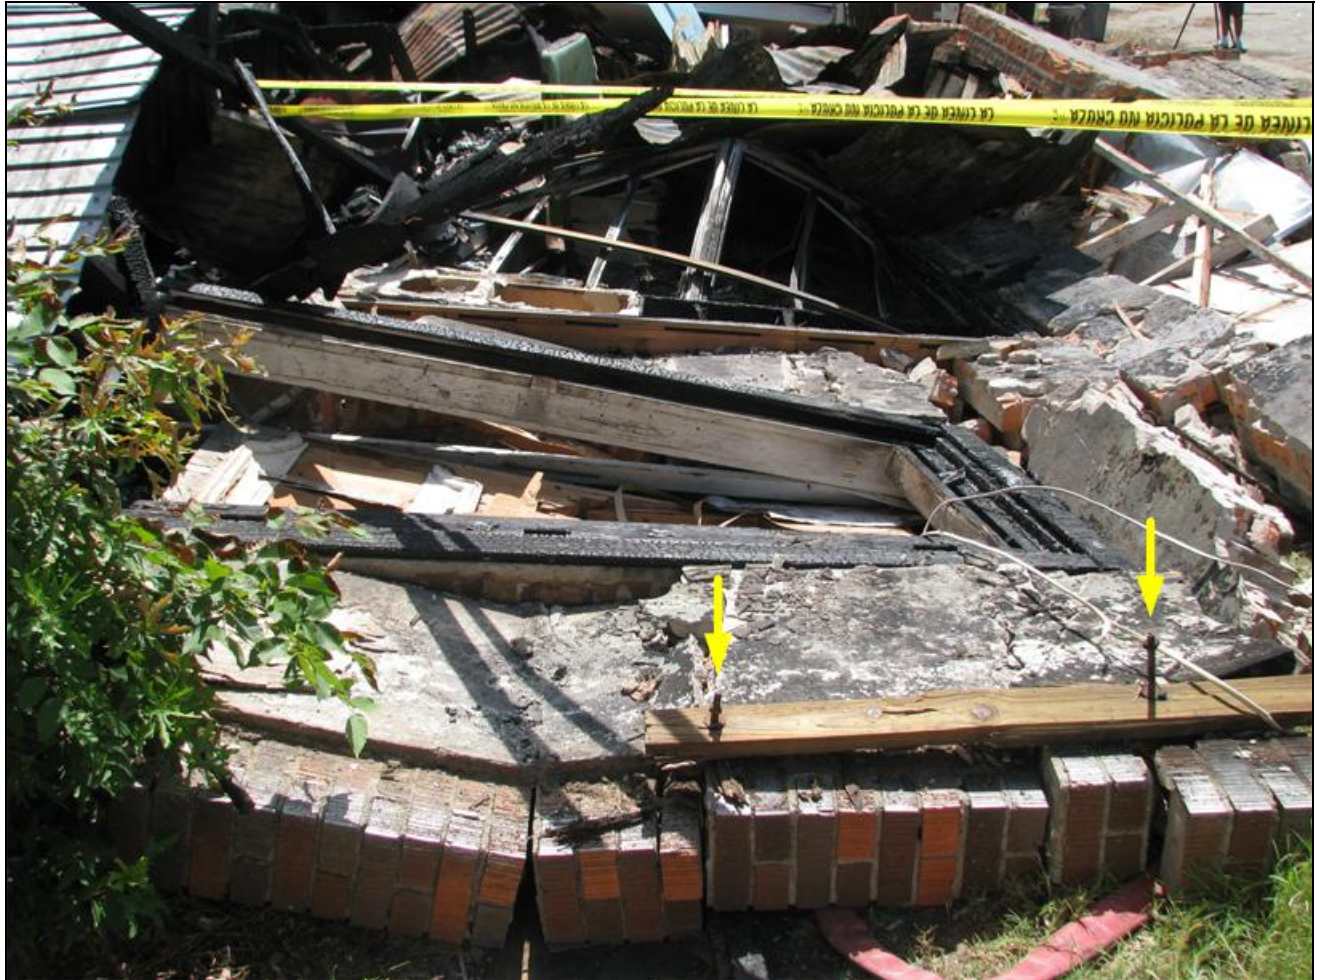
Photo 2. Side view of collapsed parapet wall. Note the short metal bolts used to attach the brick façade to the front of the structure.
(Photo courtesy of the state fire marshal's office.)

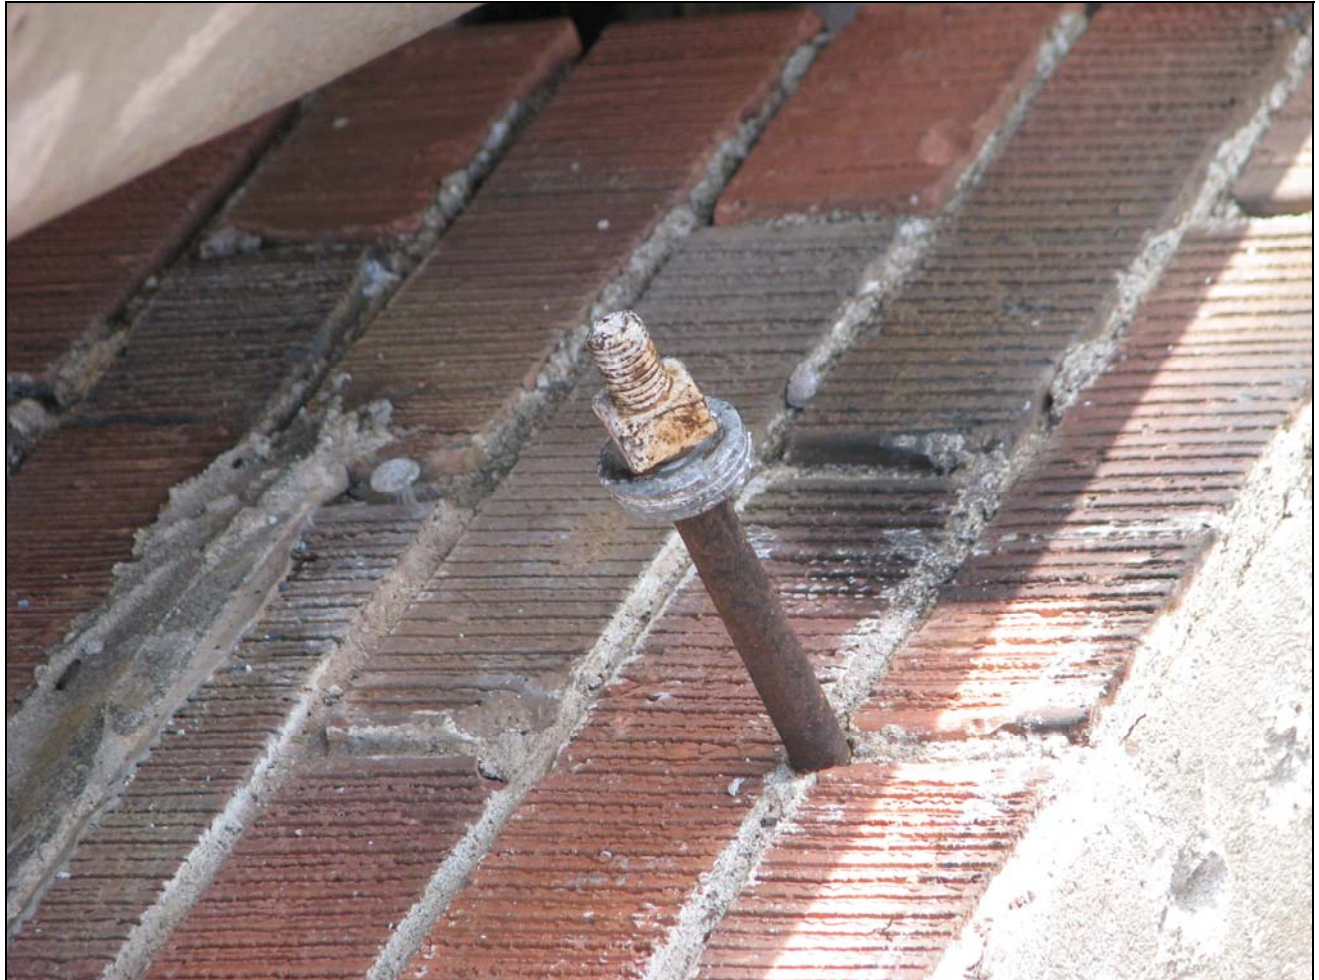
Photo 3. Close-up of short bolt used to connect brick façade to the front of the structure.
(Photo courtesy of the state fire marshal's office.)

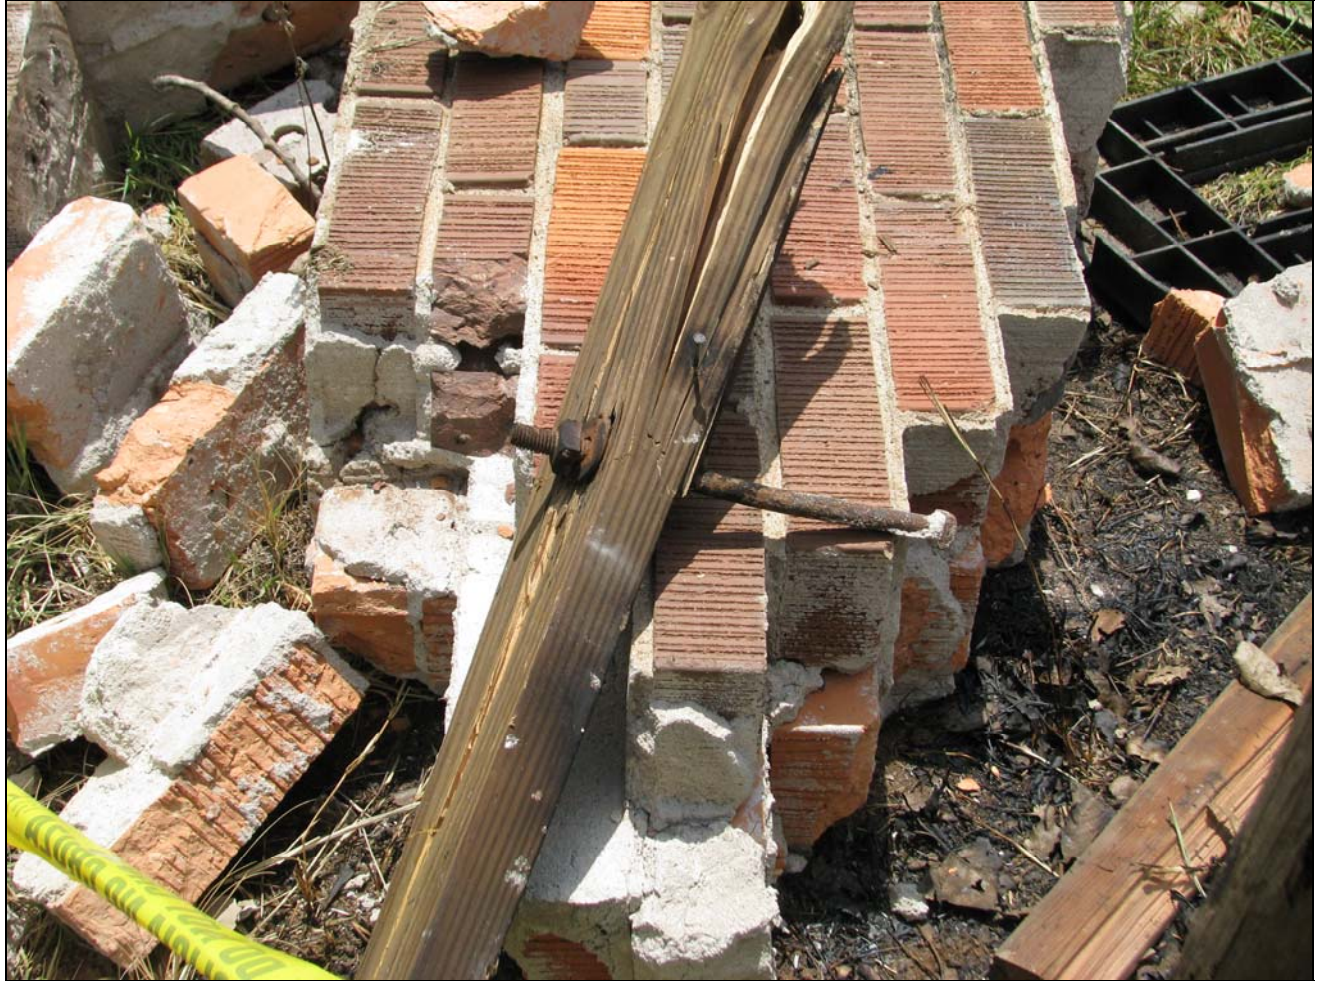
Photo 4. Another view showing the type of bolt used to connect the brick façade to the front of the structure.
(Photo courtesy of the state fire marshal's office.)

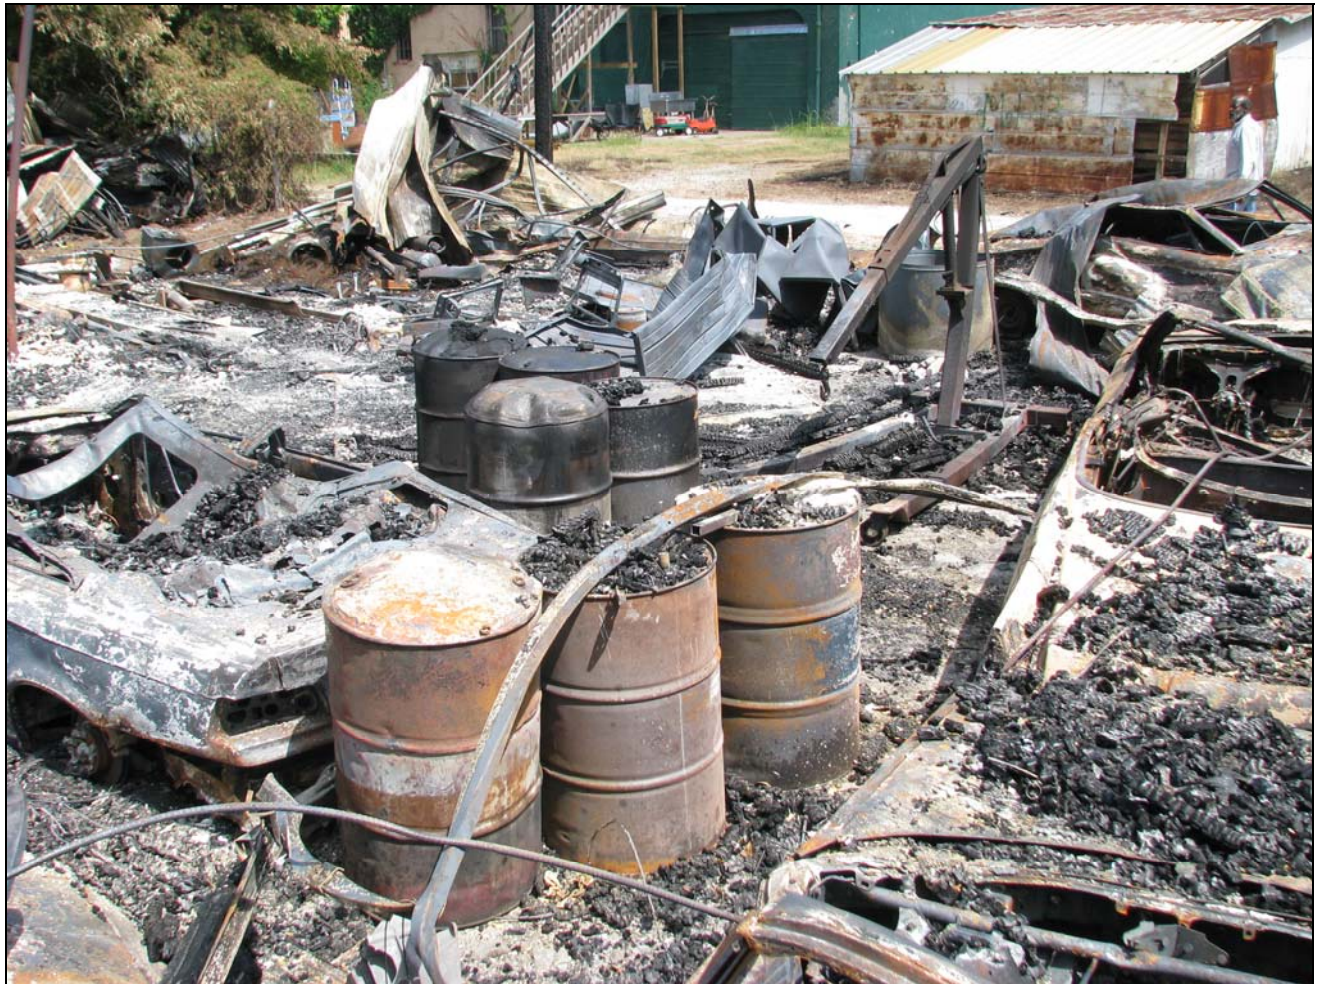
**Photo 5. Photo shows indication of the fuel load present inside the rear of the structure including automobiles, automobile parts, upholstery items, large quantities of oil, gasoline, flammable liquids, and other flammable items.
(Photo courtesy of the state fire marshal's office.)**

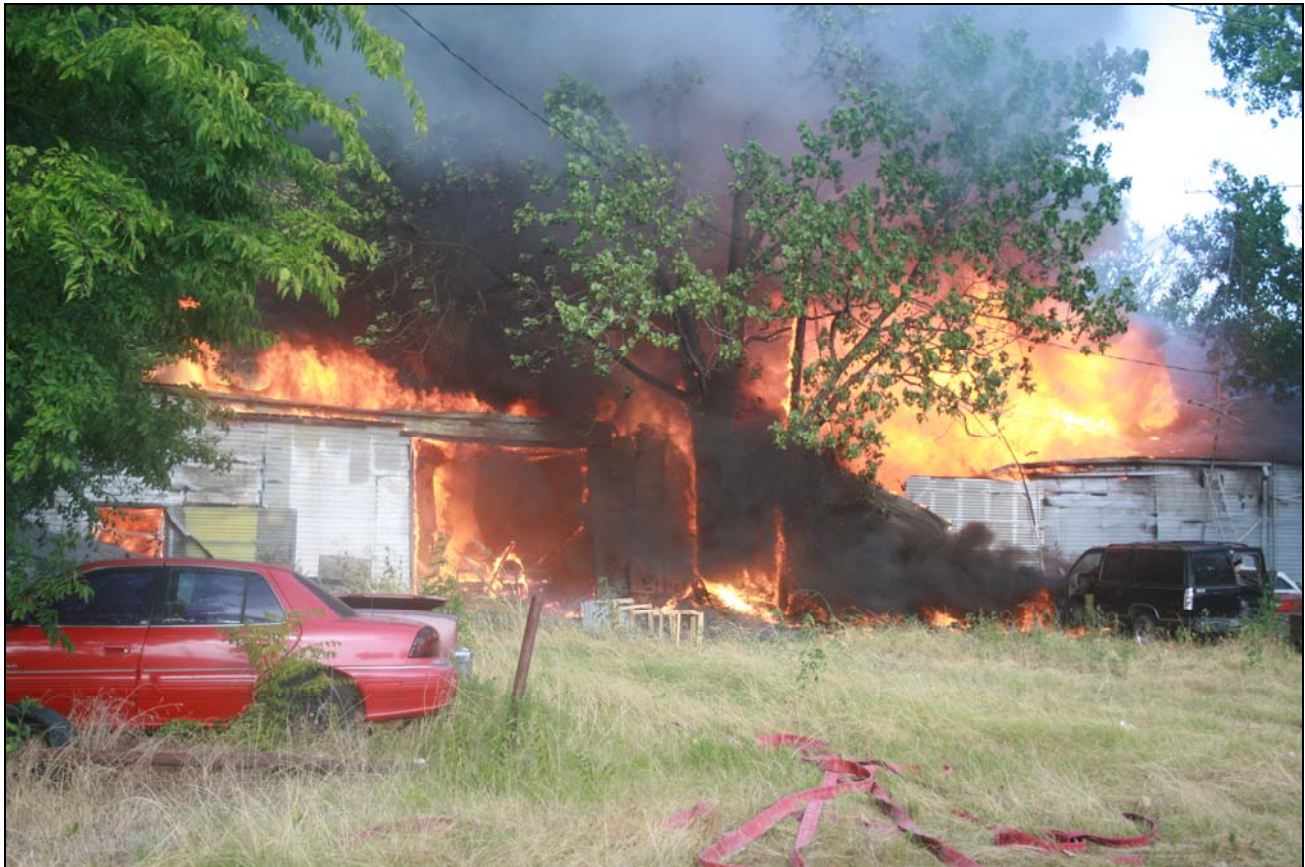
Photo 6. Photo taken from B-side near Engine 91 shows the amount of fire involvement shortly after the fire department arrived on-scene. Note the uncharged 1 ¾-inch hand line in foreground that was pulled off Engine 91.
(Photo courtesy of the fire department.)

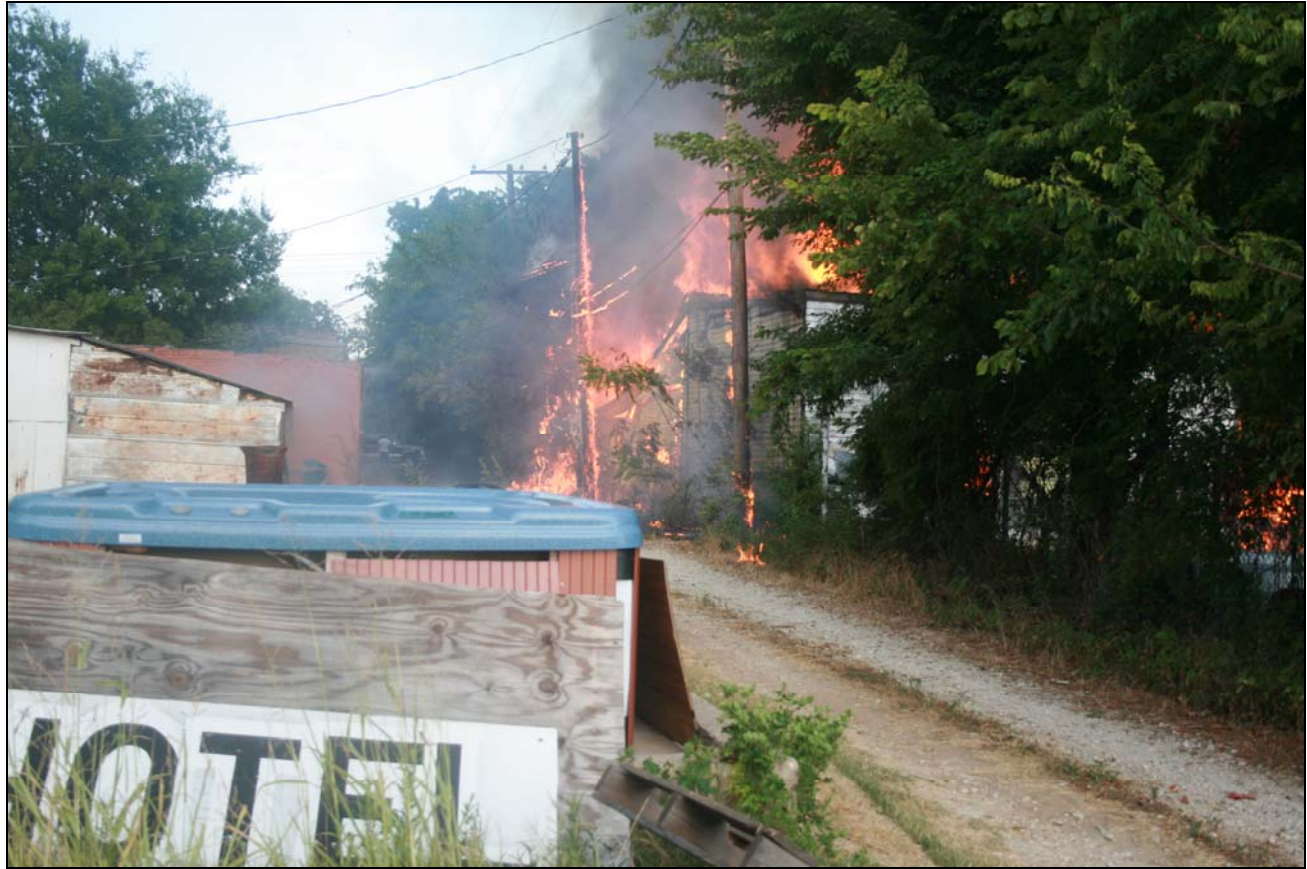
Photo 7. Photo taken from B-C corner looking down alley behind the structure. The fire is believed to have started in the painting area at the rear of the structure. Note proximity of exposure buildings left of the burning structure. The first preconnected 1 ¾-inch hose line pulled off Engine 91 was deployed in this area.

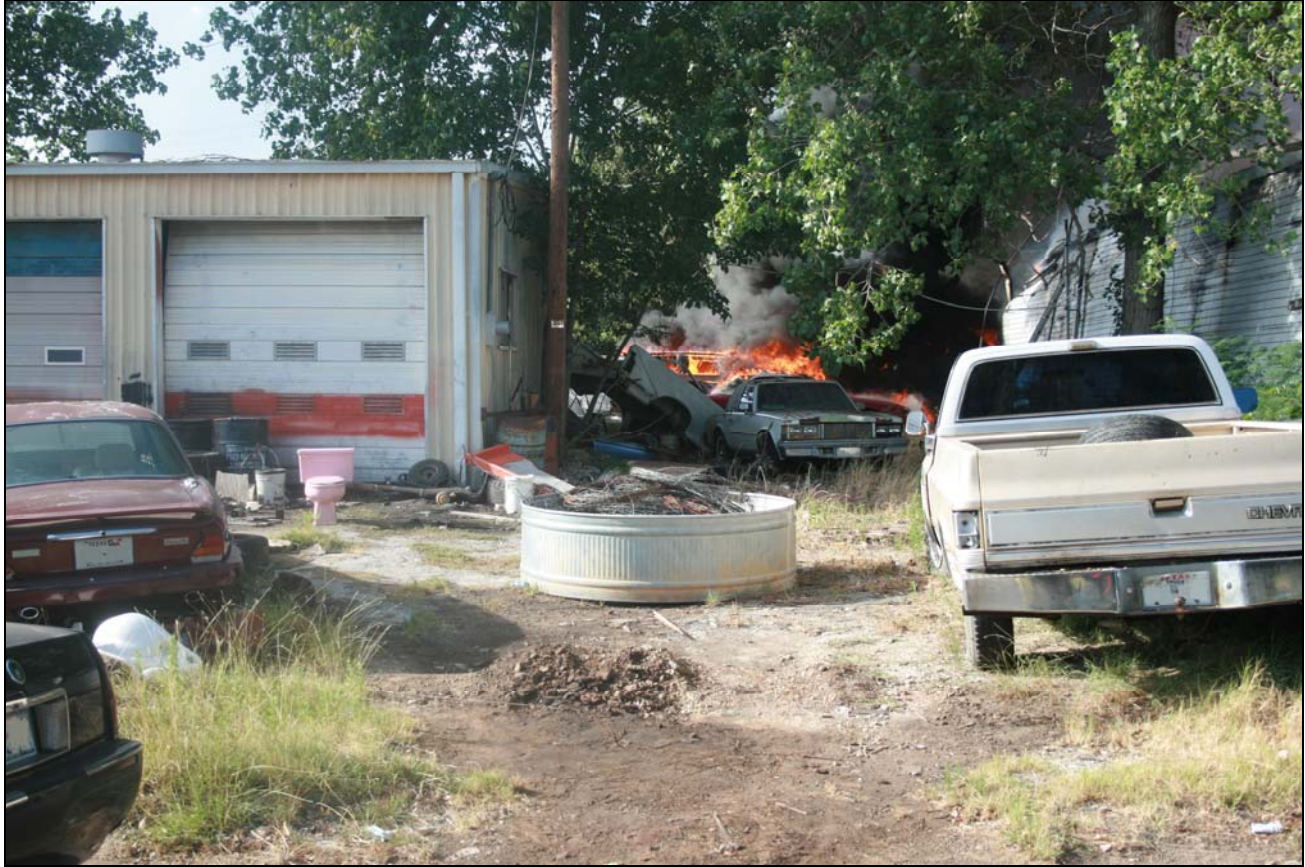
The lieutenant and fire fighter # 1 observed that Engine 91 was on-scene after they turned north on a side street as they drove to the station. They obtained Engine 92 and returned to the fire ground. The engine drove east passing a hydrant on the street in front of the burning structure. The lieutenant dismounted Engine 92 to connect the supply line to the hydrant and fire fighter # 1 positioned the engine in front of the burning structure, facing east. *Note: The rear portion of the structure along the B-side was not visible from the front. A number of items including trees, brush, vehicles, and other items restricted the view along both sides of the structure so that the fire chief likely could not see the area where Engine 91 was positioned and the Engine 91 fire fighters likely could not see the fire chief at the front. The Engine 91 crew was unaware that Tanker 96 had driven past the front of the building and dropped off the fire chief (see Photo 8).*

Photo 8. View along the B-side of the structure facing front to rear. Note that the area around the rear of the structure is not visible. Engine 91 was positioned beyond the burning vehicles in the center of the picture. It is likely that the Engine 91 crew never saw the fire chief in this area and also that the fire chief never saw the Engine 91 crew.

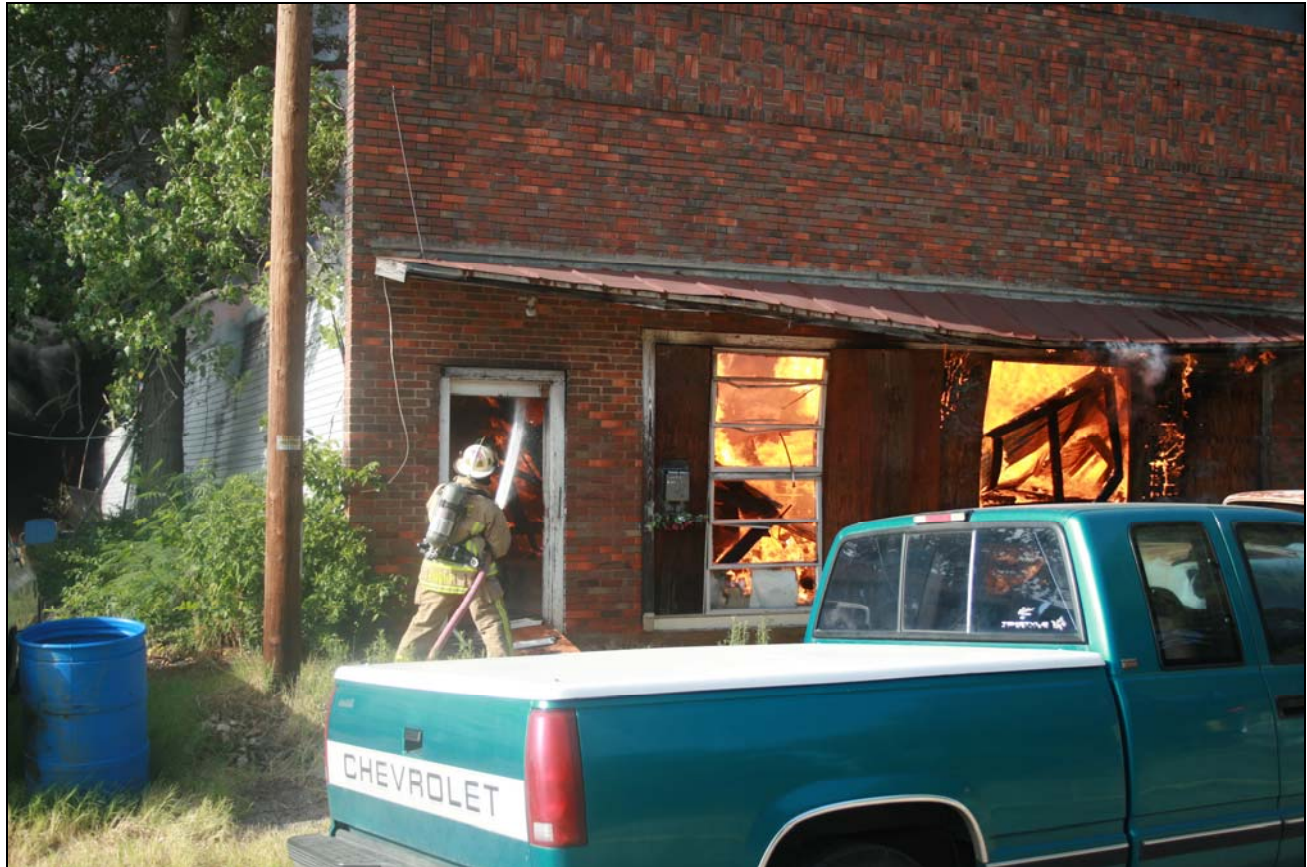
Photo 9. Photo taken from the street showing fire chief with a 1 ¾-inch hand line in operation at the doorway at the front of the structure (A-side). Note the amount of fire burning at the front of the structure. Photo was taken just seconds before the brick wall collapsed.

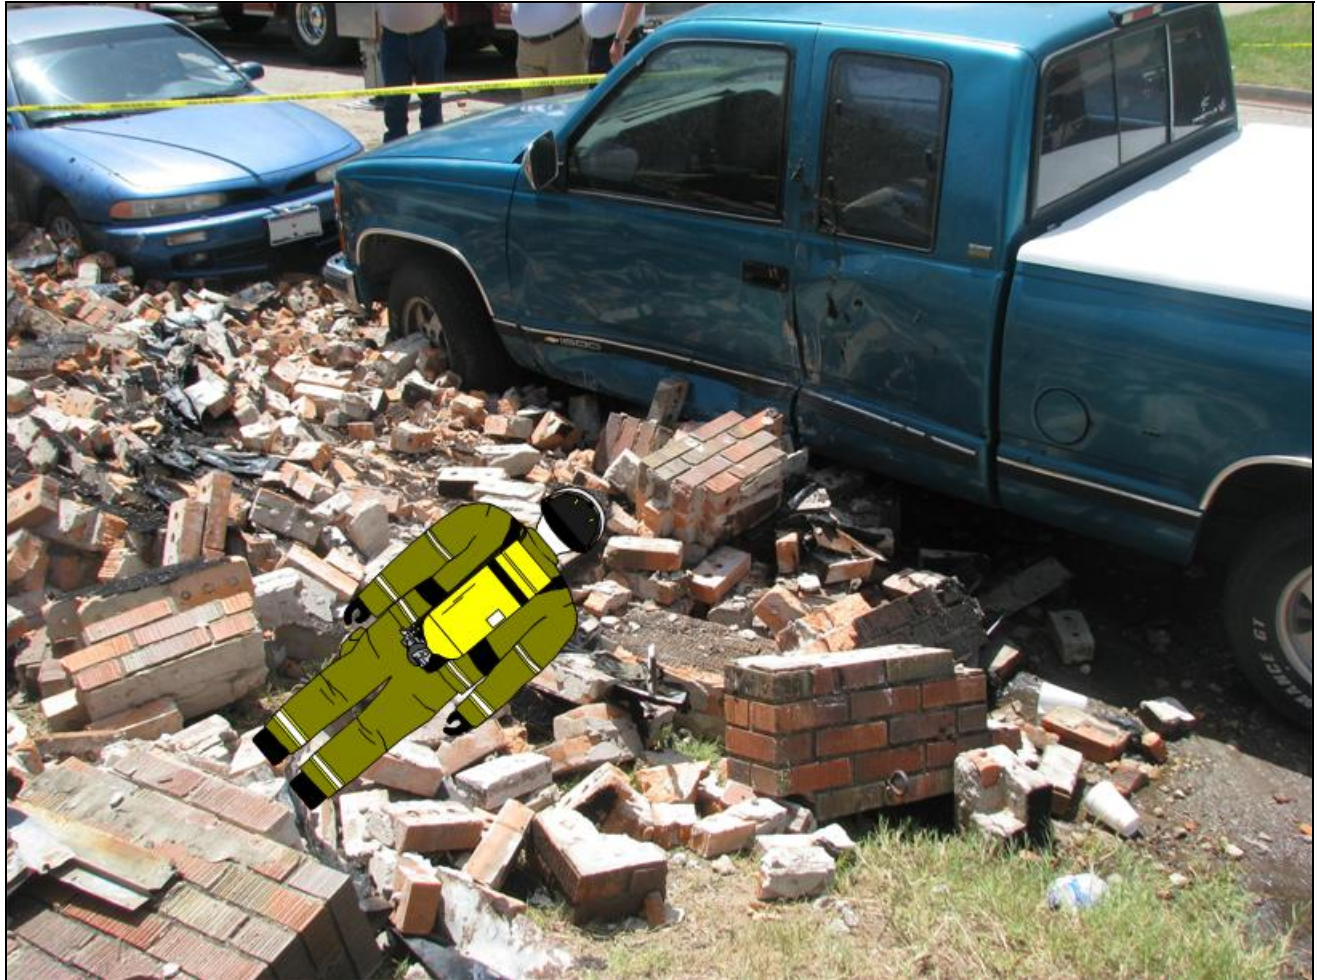
Photo 10. Approximate location where the Fire chief was buried by the collapsing brick wall.
(Photo edited by NIOSH from photo provided by the state fire marshal's office.)

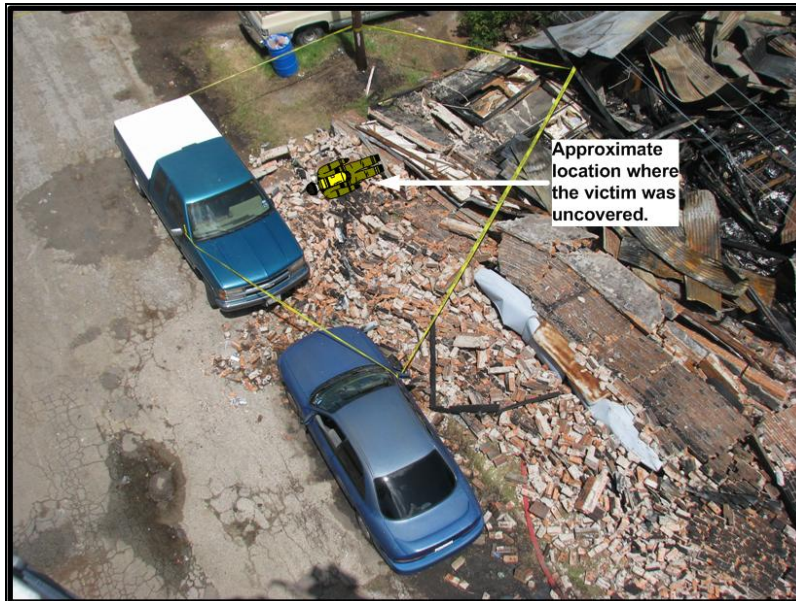
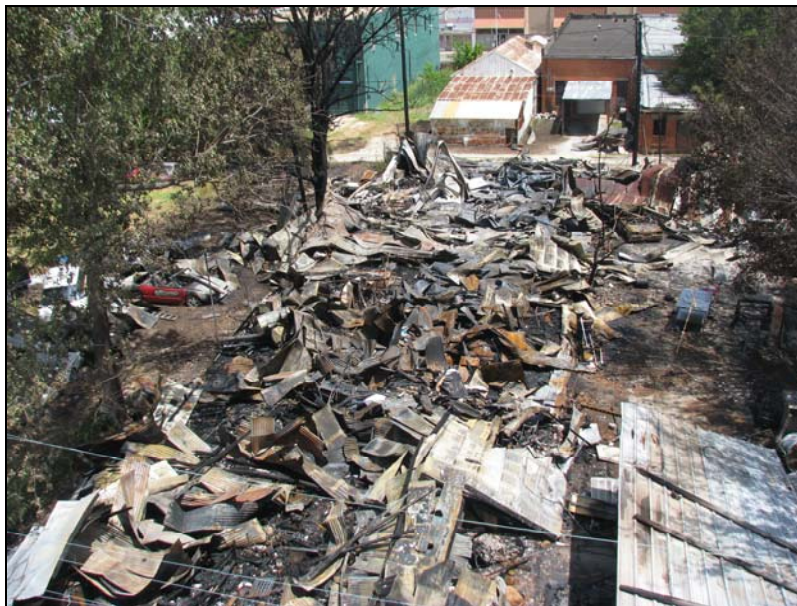
Photos 11 and 12. Photos taken post-fire from elevation viewed front to rear. Photo 11 shows the location where the Fire chief was extricated from the collapsed wall.
*(Photo 11 edited by NIOSH from photo provided by the state fire marshal's office.
Photo 12 courtesy of the state fire marshal's office.)*
